APPENDIX 5f
Remediation plan for Sample #67 area

**Update to the Kittiwake Letter of Application from the Cayman Islands
Department of Transportation, MARAD, dated November 5th, 2006
Updated January 23, 2008**

**Kittiwake Paint Test Results: Original Batch of 121 Samples
May 17, 2006
Universal Laboratories, Hampton, VA**

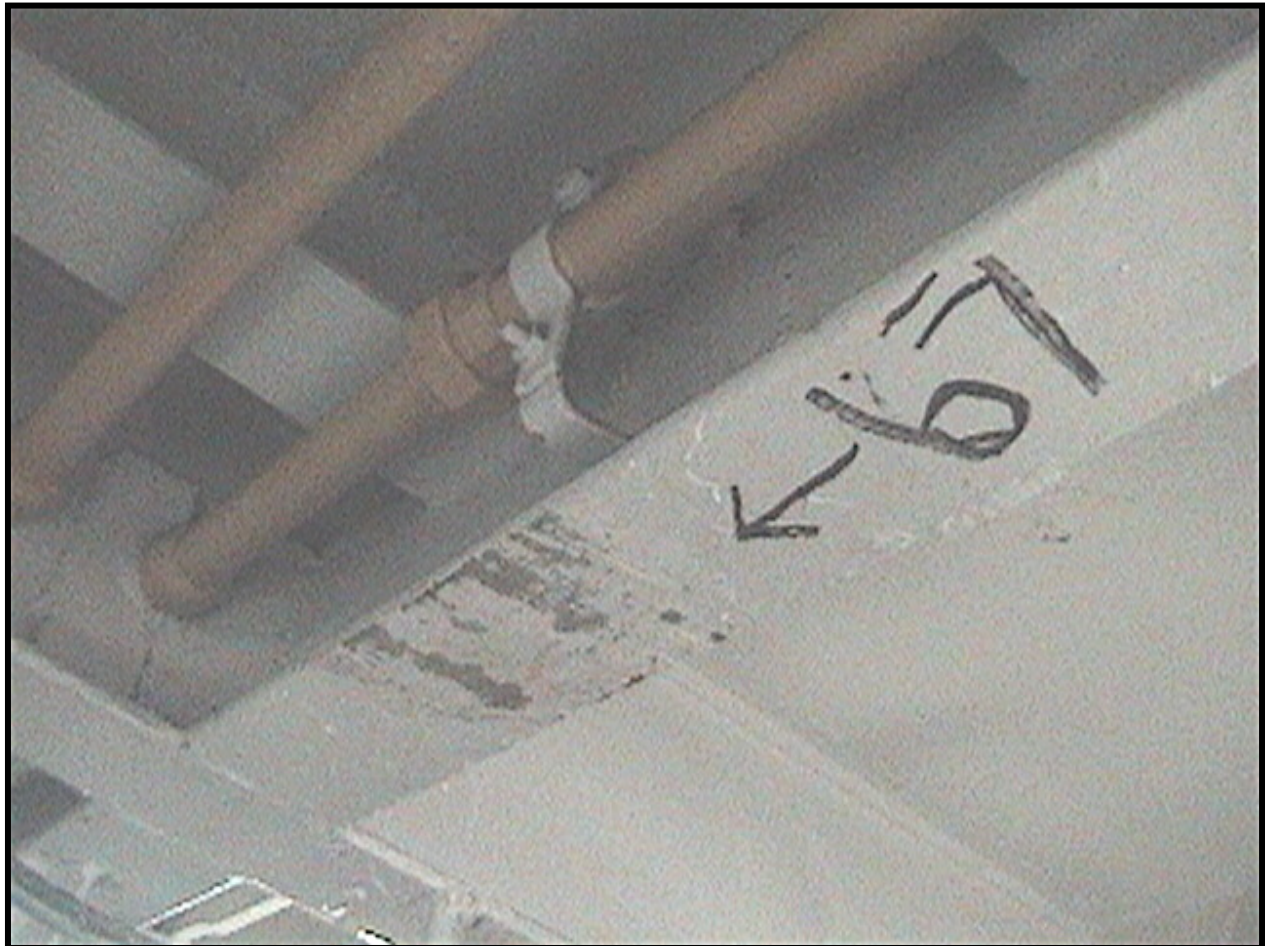
One sample indicated a concentration level of 108ppm of Arcolor 1262. This is referred to Sample #67. The sample was taken on the overhead, main propulsion, lower starboard side B-204-E Frame 79. The sample was white paint. Of the 121 samples taken, there were a total of 35 samples that were white paint, with none of the other white paint samples showed any Arcolor 1262. Other white paint samples were taken from the fan room, interior bulkheads, shaft alley, diving bulkhead, recompression chamber and overhead, bulkhead in welding, forward bulkhead including distribution compressor, lower main engine room, air compressor room, lower storeroom, electronics storeroom, bosuns lockers, overhead above the generator sets, overhead main propulsion, sonar room and main propulsion room. All white paint, including sample #67 is common, standard Navy white paint (150 or 151).

Due to the concentration of Arcolor 1262 found in Batch 1 sample #67, a second batch of paint samples were taken in the same vicinity as sample #67 was found. The results of both of these samples (001 and 002 - lab report attached) shows an even higher concentration level of Arcolor 1262 of 3,400,000 ug/kg (equivalent to 3,400ppm). This data would indicate that the original sample #67 was at the outskirts or edge of the contaminated area, and that the second batch of re-sampling has found the core of the contaminated area.

Kittiwake Paint Sample #67 – PCB Contamination area on the overhead

Our remediation plan is to remove all metal and paint (everything) from the affected area, instead of just removing the paint. The effected area is in the engine room, on the underside of the deck, between the upper and lower engine room. The area is on the starboard side within the watertight space, but does not make up any part of the watertight shell, and removing the steel from this area would simply be a diver penetration or access and not affect the ship's water-tight integrity for towage or sinking. We have sampled the affected paint area until a clean or non-contaminated area in a 360 degree circumference of the contaminated area is found. We will remove all paint in this area making a clean margin, and then using a plasma cutter, we will cut out the metals and steel and dispose of the paint and steel as PCB contaminated materials.

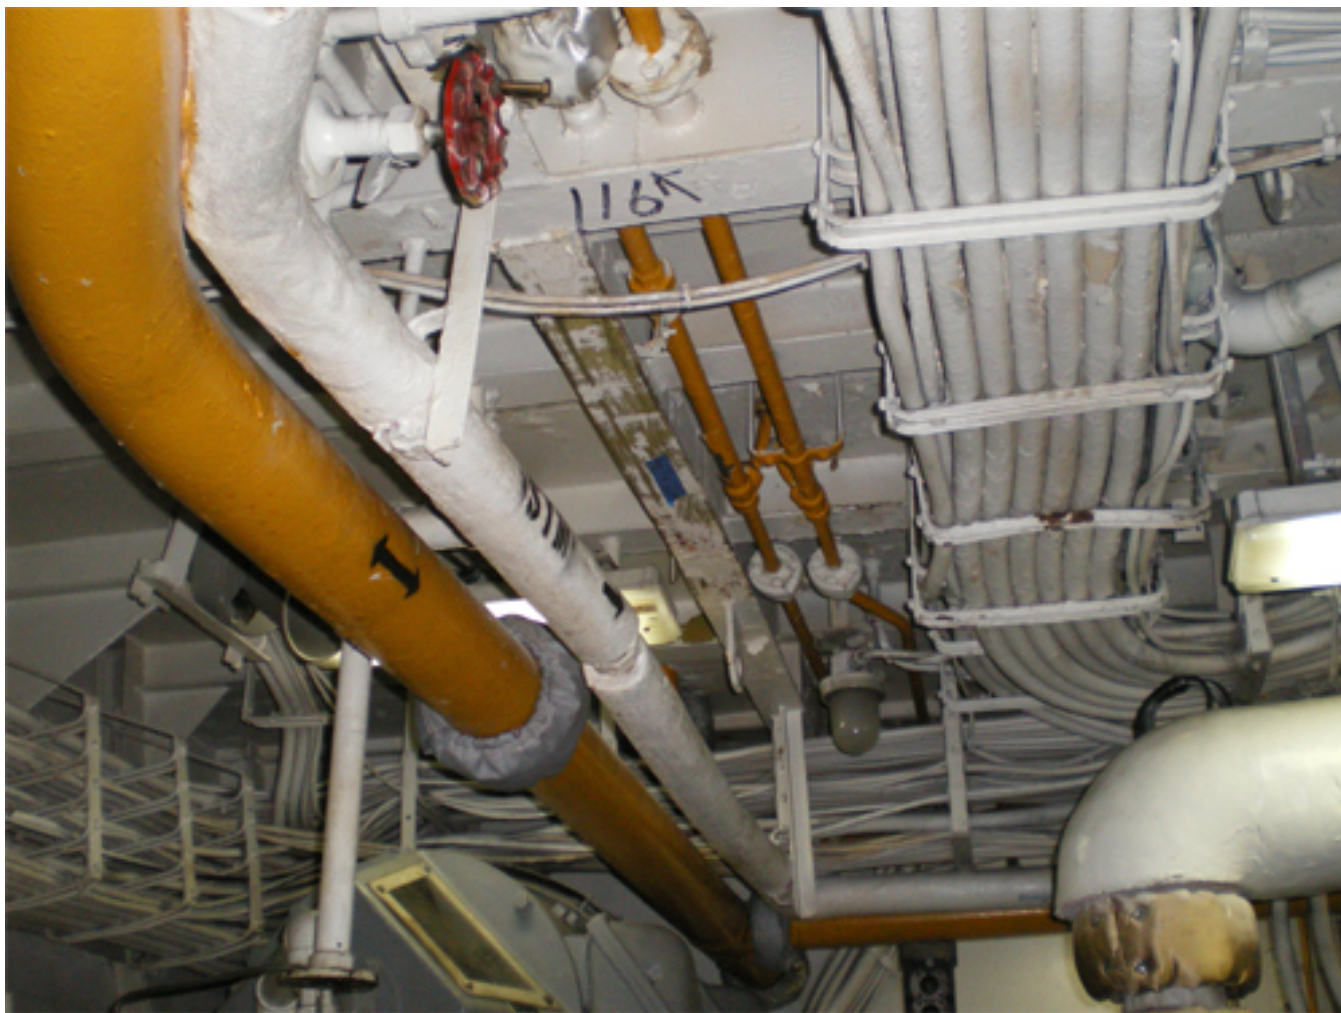
APPENDIX 5h
Photo of second sample site near original sample #67

The blue tape shows sample #67 from first batch of samples. The second sample site was just extended for the two confirmatory samples.
